Case Study:

Success at The Ritz Carlton[®], Bachelor Gulch in Beaver Creek, CO with Sashco's Capture[®] and Cascade[®] log stain system

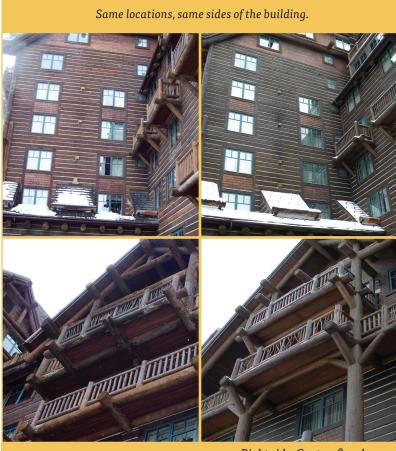
A side by side comparison...

Left side: Sikkens[®] after 5 years.

Right side: Capture[®] and Cascade[®] after 5 years.

In late 2016, after the first five-year maintenance cycle of Capture[®] and Cascade[®] was complete, Sashco revisited the the resort to see how things were looking. The team from Sashco was pleased to find the Capture[®] and Cascade[®] holding up really well.

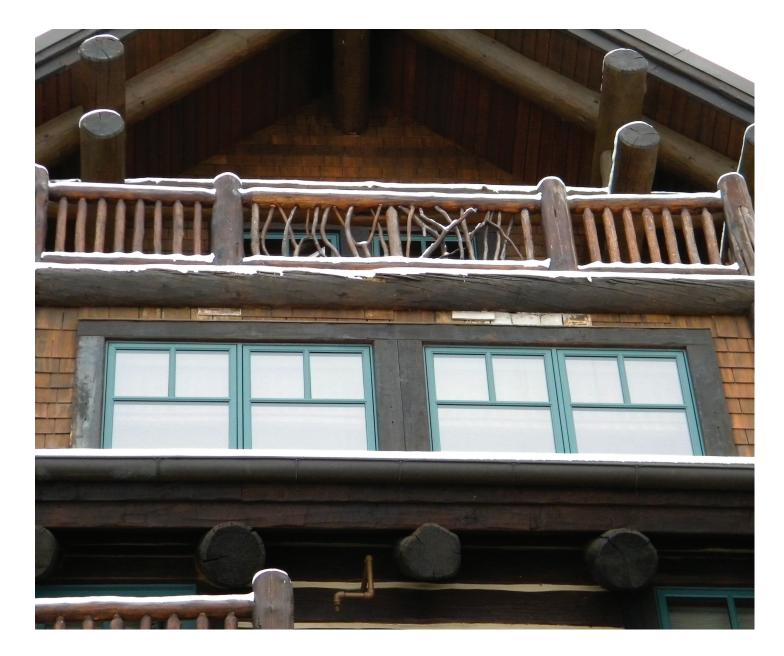
The Ritz Carlton[®], Bachelor Gulch team continued to experiment with different products, as seen on this railing. Ultimately, they decided to stick with the Capture[®] and Cascade[®] system on the exterior wood surfaces, both because they saw better performance out of the Sashco products, and because they were able to maintain a consistent color and appearance using the same product everywhere.
